THE MALDEN SURVEY

A REPORT ON THE CHURCH PLANTS OF
A TYPICAL CITY, SHOWING THE USE
OF THE INTERCHURCH WORLD MOVE-
MENT SCORE CARD AND STANDARDS
FOR RATING CITY CHURCH PLANTS

WALTER SCOTT ATHEARN

Copyright 1920 by the
Interchurch World Movement
of North America

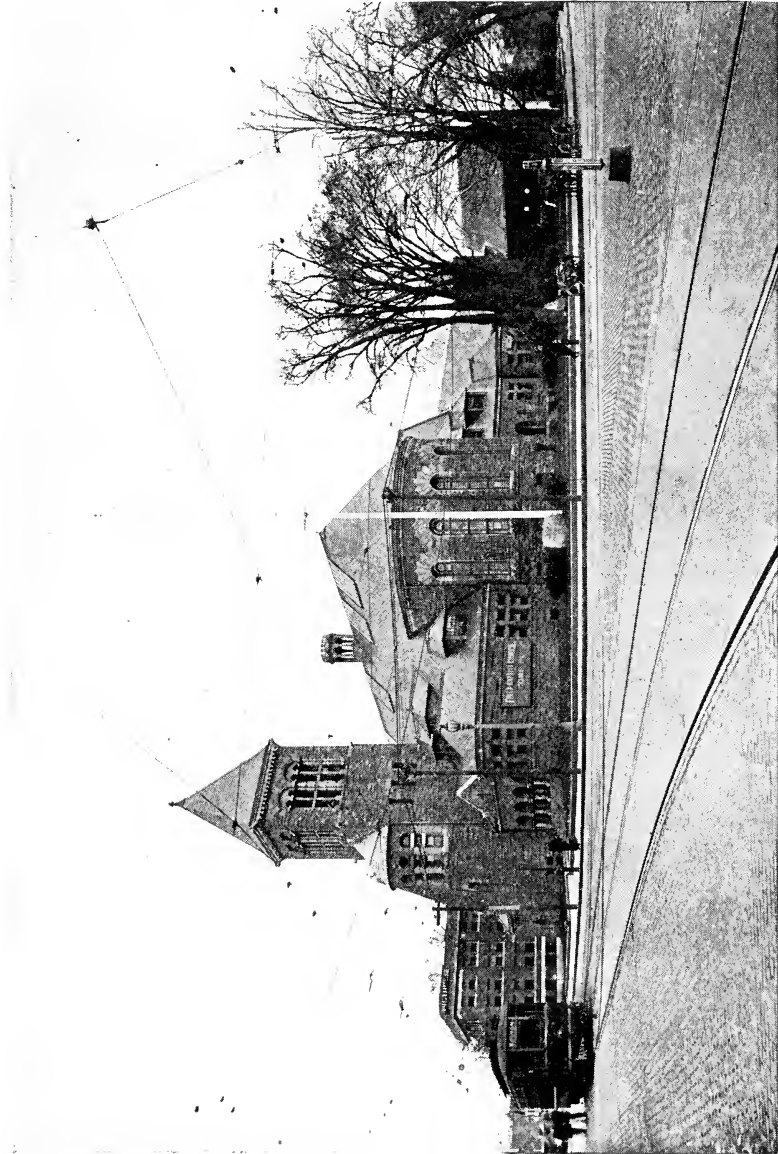
ILLUSTRATION I. FIRST BAPTIST CHURCH

The score allotted to this church and religious education plant indicates that in many ways it conforms to the standards developed for an ideal plant. The buildings are located at the intersection of two of the main streets of the city and in close proximity to other community buildings such as the public library and the public high school. The buildings would make an attractive addition to any community.

The outstanding features of this plant are the well-planned auditorium, the satisfactory service systems, the large number of high grade and separate classrooms and the exceptionally well-equipped kitchen. The limitations of the site, the unsatisfactory natural lighting of some of the rooms, and the omission of certain community service rooms included in the score card have placed this building in the 700-800 point group. Because the main church is a reconstructed building with the limitations which that puts upon room arrangement and the like, the First Baptist does not receive the perfect score on a number of items. It is the loss of the few points on many items which reduces the total score, and not the failure to provide accommodation for all forms of service.

The general environment of the First Baptist Church is materially heightened by the presence of the public library. This is clearly shown in illustration 1, page 18, which shows the location of the First Baptist plant at one of the most central street intersections in the city. The increased effect which can be secured by planning buildings, which are to serve community needs, in architectural harmony with each other is quite evident in this case. Such proximity causes each building to render the other more imposing without in any way detracting from it. The general neighborhood of the First Parish in Malden Universalist Church is attractive, as is that of St. Paul's, to a certain degree. There are elements of attractiveness in the location of other plants, such as the Mystic Side Congregational and the Robinson Methodist. Illustrations No. 8 and No. 5, pages 32 and 26 show these buildings located in their general environment. There is every evidence that the location of the majority of the seventeen plants was not prompted by visions of extensive community

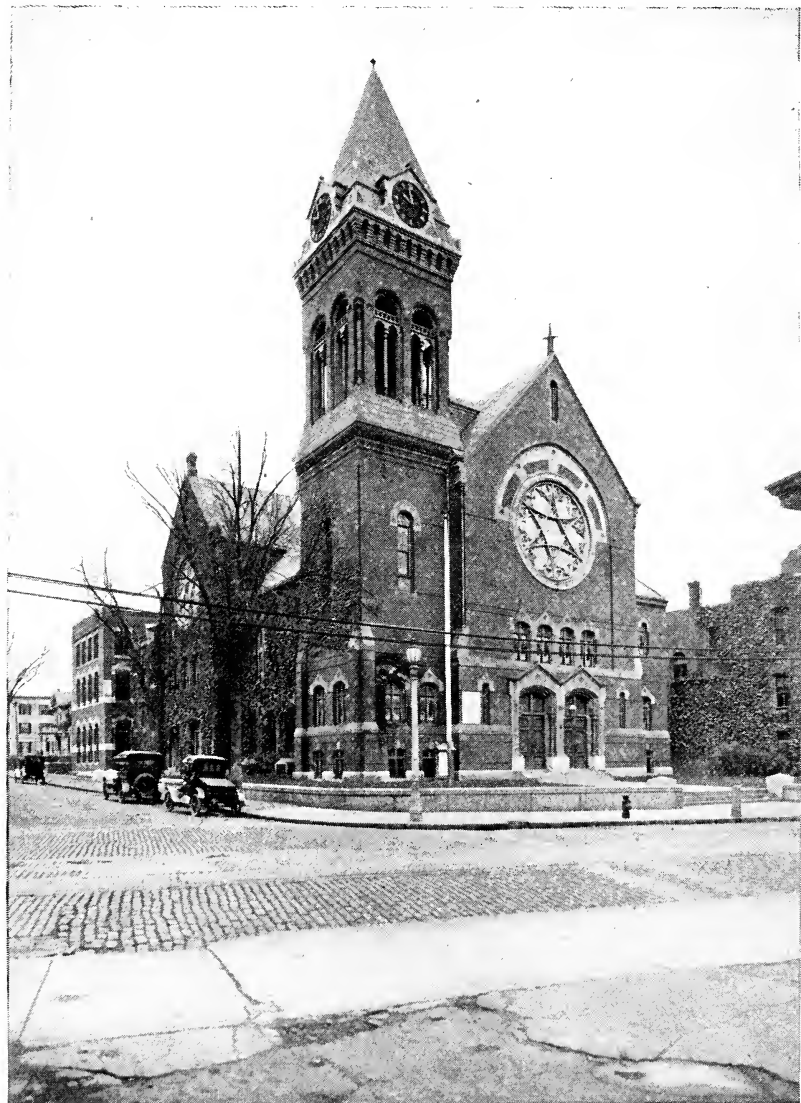
ILLUSTRATION 2. CENTRE METHODIST CHURCH

The emphasis placed by this church upon a high-grade church auditorium with its desirable equipment and upon a religious school equipment which permits of the segregation of many classes is evidenced in the detail score given these items. The building is located on a corner site with non-fireproof business houses in the immediate neighborhood. The size of the site has necessitated building upward. This has produced a second story auditorium and a three story school building, which should be allowed only in highly fire resistive construction. No out-of-door activities are possible on this site. The location of this downtown church opens great possibilities for community service which cannot be adequately met by the limited existing provisions. The vacuum cleaning and elevator service installations are striking features of this plant.

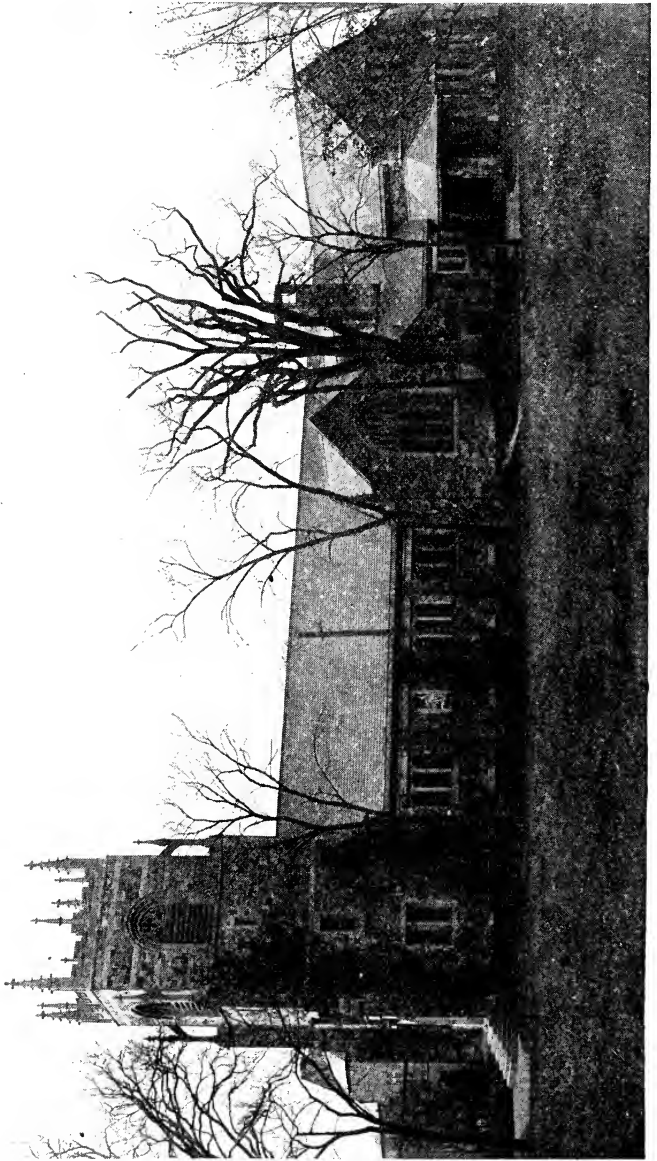
ILLUSTRATION 3. FIRST PARISH IN MALDEN, UNIVERSALIST CHURCH

Conspicuously and pleasingly located on an intersection of streets the First Parish in Malden, Universalist, is one of the most striking and attractive churches in Malden. It is unfortunate from the standpoint of the service which this church should render that so picturesque an exterior should be handicapped by an interior equipment and arrangement inadequate in many respects. A beautiful auditorium is partially spoiled by insufficient light, the corridors are narrow and poorly arranged, the stairways are winding and inadequate, the classrooms are too few in number, poorly lighted and poorly equipped; the service systems are in many cases inadequate, while the element of fire protection has received very little consideration, either in the basement where the furnace is located, or in the ease with which large numbers can get from one part of the building to another. The church has made commendable provision for some forms of special service neglected in many of the other churches in Malden, even though these do not meet the standards set by the score card. Some of these are the pastor's study, recreation room, auditorium with stage, and dining room and kitchen. The convenience of the rooms and the service of the church could be materially increased if several of the rooms were rearranged with this in mind.

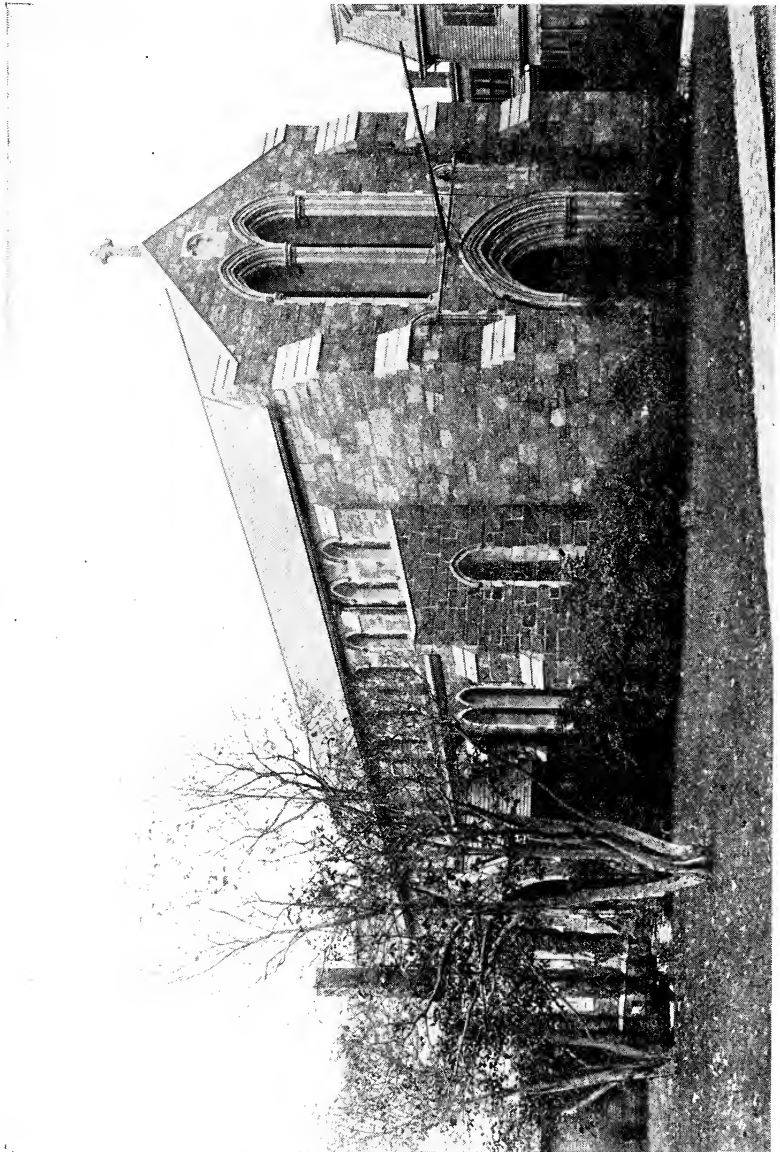
ILLUSTRATION 4. ST. PAUL'S EPISCOPAL CHURCH

If the high standard set in the construction of the new church auditorium section of this plant had prevailed throughout, the score allotted would have been very much higher. This new section accounts for the 112 points on church rooms and for much of the score on Item II. It is hoped that, when the old sections of this plant are replaced by new buildings, the standards of this score card will be used as a guide. There will be a distinct need for additional land if the desirable standards are reached. It has already been recognized by the members of St. Paul's Church that the present school and community provisions are totally inadequate.

The attractive elements in the present situation are the harmonious relationship between the landscape and the new building and the ease of entrance and exit to the new building.

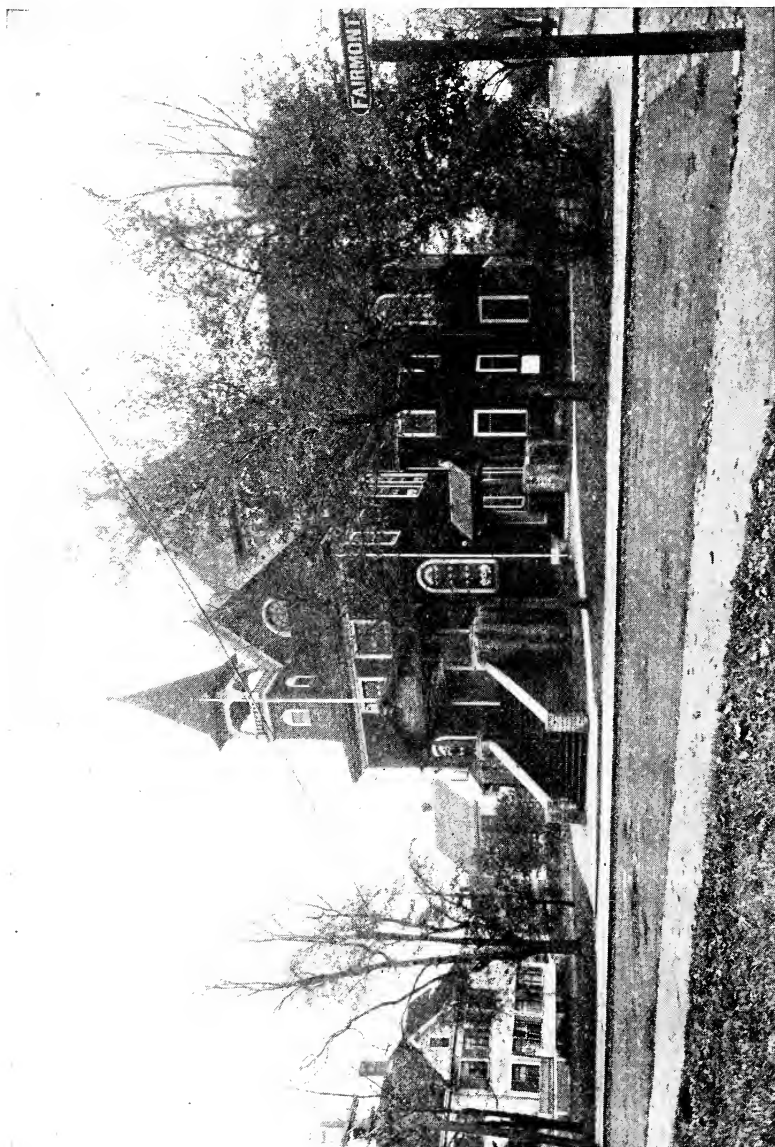
ILLUSTRATION 5. ROBINSON METHODIST CHURCH

The church is unfortunate in its main entrance and in its second story auditorium. The present structure is the result of an addition to an older building. A better plan would have involved discarding the old structure, increasing the size of the site and building a fire-resistive structure which embodied the standards set up by modern needs.

Attractive elements in this situation are the library and the homelike tendency in the rooms of the first floor.

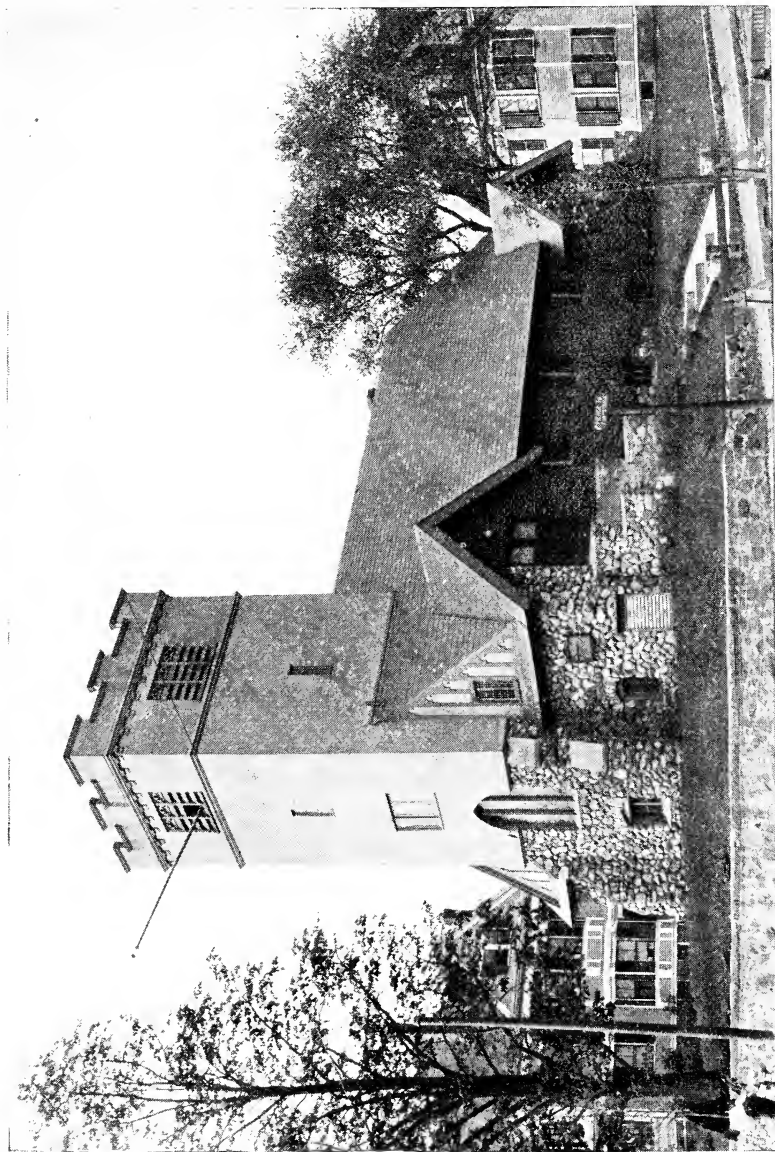
ILLUSTRATION 6. FAULKNER METHODIST CHURCH

This church presents an attractive exterior. Although its construction is recent as compared with that of many of the other Malden plants, there is little evidence of planning for the future in its site, the plan of the building or its equipment.

The site, although much more satisfactory than others, will never suffice for a large community plant, the need for which will arise in this locality. The building lacks to a large degree desirable educational and community service provisions. The attractive elements in the case are the artificial lighting of the auditorium and the pleasing exterior. Little else about the building commends itself for mention.

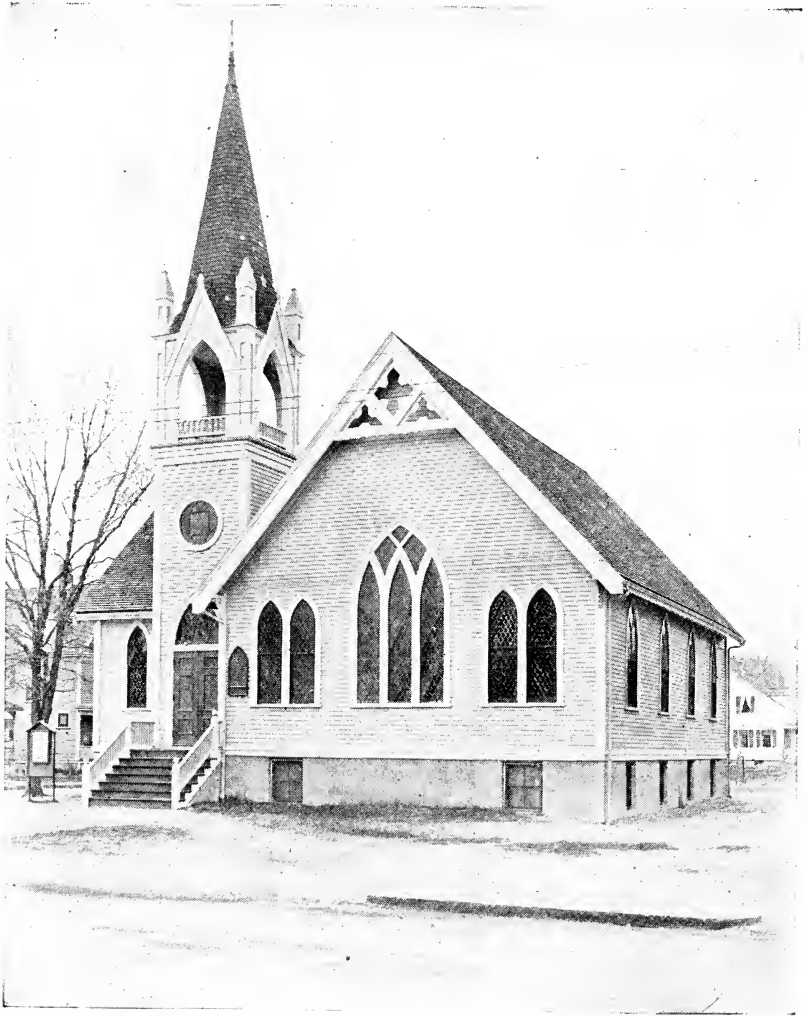
ILLUSTRATION 7. LINDEN METHODIST CHURCH

This building was scrupulously clean throughout. Its equipment was simple, yet well cared for. Its ornamentation was inexpensive yet attractive and gave evidence of much thought.

No doubt, although the site is small, the service systems limited, and auxiliary rooms few in number, the plant is, in many respects, efficiently serving its patrons.

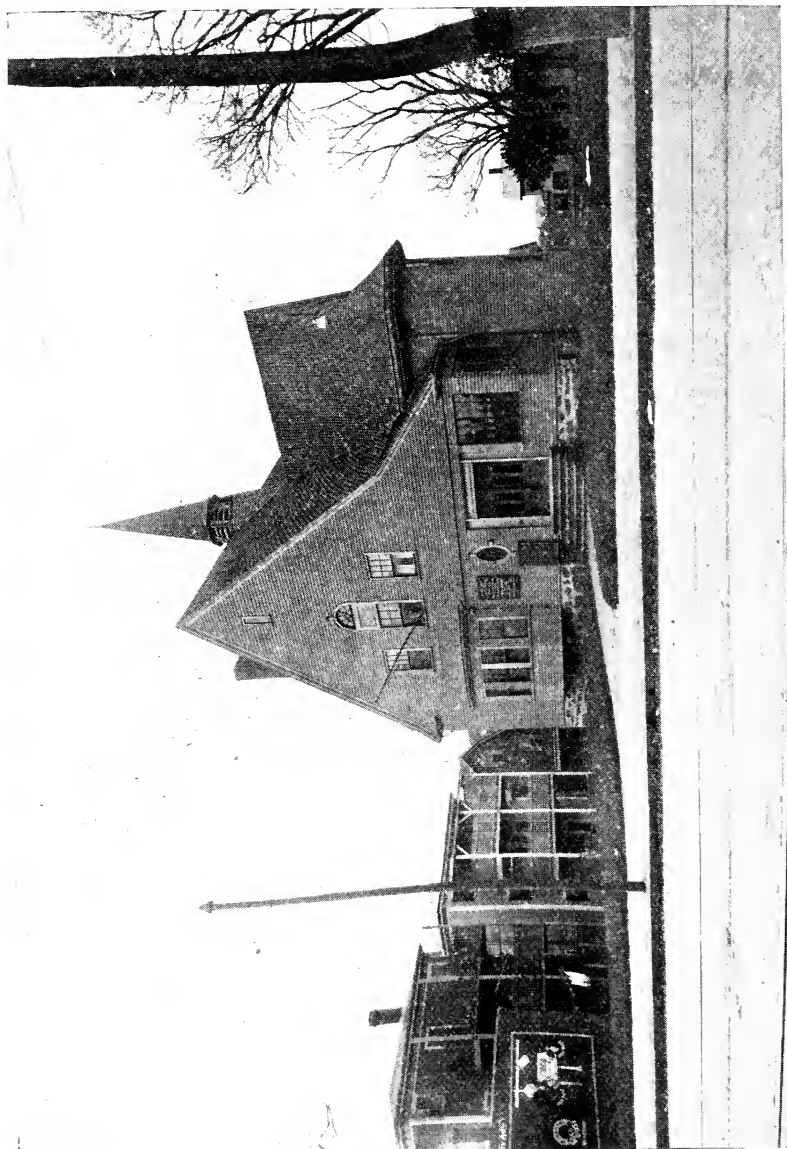
ILLUSTRATION 8. MYSTIC SIDE CONGREGATIONAL CHURCH

This church falls in the 350-400 point group. The outstanding features of the plant are the relatively large site, the attractive front classroom and the businesslike pastor's study.

The congregation has outgrown this plant and has already planned to build a new structure. It is hoped that the faults of the old building will be eliminated in the new. In this building the fire danger is ever present, the kitchen facilities are very poor, the toilets fail to reach a satisfactory standard, storerooms are inadequate, the lighting system is defective, the kindergarten room unfortunately placed and many desirable features are lacking entirely.

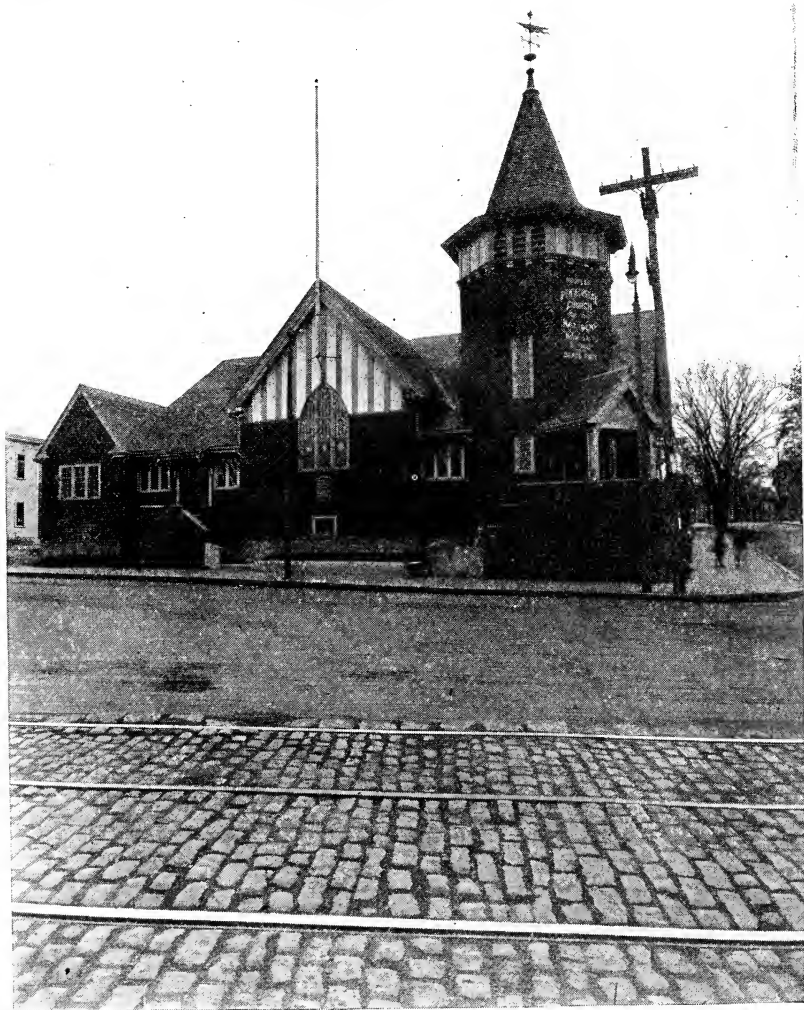
ILLUSTRATION 9. PEOPLE'S PENTECOSTAL CHURCH OF THE NAZARENE

This church is well located on a corner lot and so orientated as to command the best possible lighting. It is a relatively new structure but of a construction more typical of residences than of churches. The site is so small that the church almost stands on the sidewalk. The interior of the church is very attractive, with plain walls, well-harmonized woodwork, artistic and efficient indirect lights and new and well-kept furniture. The general effect is somewhat spoiled by some large water stains on the walls resulting from leaks, which in turn were results of light construction. The basement is very small, extremely low and entirely exposed to fire risks from the furnaces. The provision for religious education rooms is convenient as an enlargement of the auditorium, but neither well-arranged nor adequate for graded instruction. The fact that the pastor's home is attached to the church makes it possible for him to be directly in touch with the work of the church. The score of this church is lower than it otherwise would be because of the entire absence of all rooms for community service—a provision which the church does not believe in making.

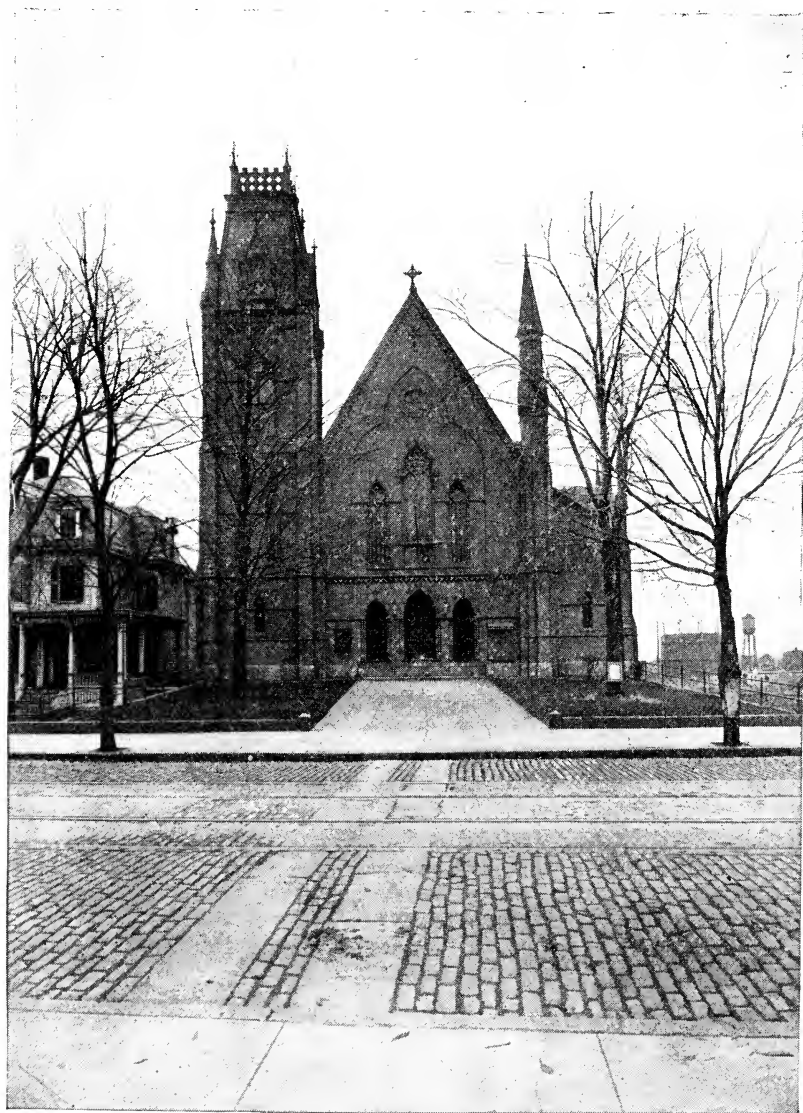
ILLUSTRATION 10. FIRST TRINITARIAN CONGREGATIONAL CHURCH

Constructed long before the extensive community service suggested by the score card standards was required of churches, this plant is found deficient in many particulars. The maintenance of this building has been high-grade with the exception of the basement. Its location was at one time much more desirable than today. The environment indicates that the church is gradually being crowded out by industrial and commercial developments.

The largest number of points has been allotted this building in its church rooms, especially its auditorium. The almost total lack of classrooms, the limitations of the community service rooms and its non-standard service systems account for much of the low score.

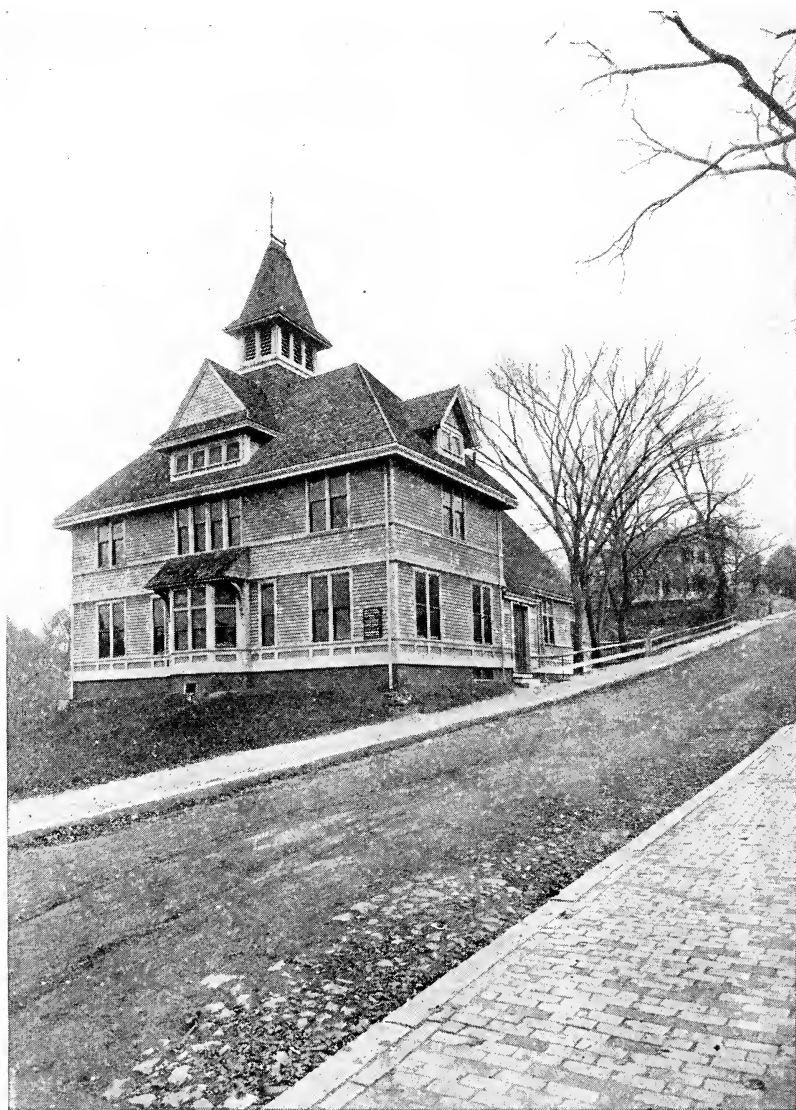
ILLUSTRATION 11. EASTERN AVENUE BAPTIST CHURCH

This church has little to recommend it to the passerby. Its site is undesirable and the building in many ways does not even resemble a church. Its interior, however, is commendable in many respects, which accounts for its receiving a higher score than would appear warranted from an outside view. The building is scrupulously clean even to the basement, the decoration of walls and ceiling is recent, harmonious and attractive and the service systems, while far from standard, are efficient and in a good state of upkeep. The congregation has given most of its attention to the efficiency of its church rooms which receive a relatively high score. In addition to the main auditorium, provision has also been made for a small assembly room which can also serve for church board meetings, for a special room equipped for communion services, for a pastor's study and for a church office.

When the plans that are now being discussed for finishing the basement and making adequate provision for preparation rooms for baptismal ceremonies are made actualities, this church will find its opportunities much increased and will be approaching a maximum use of a poor building.

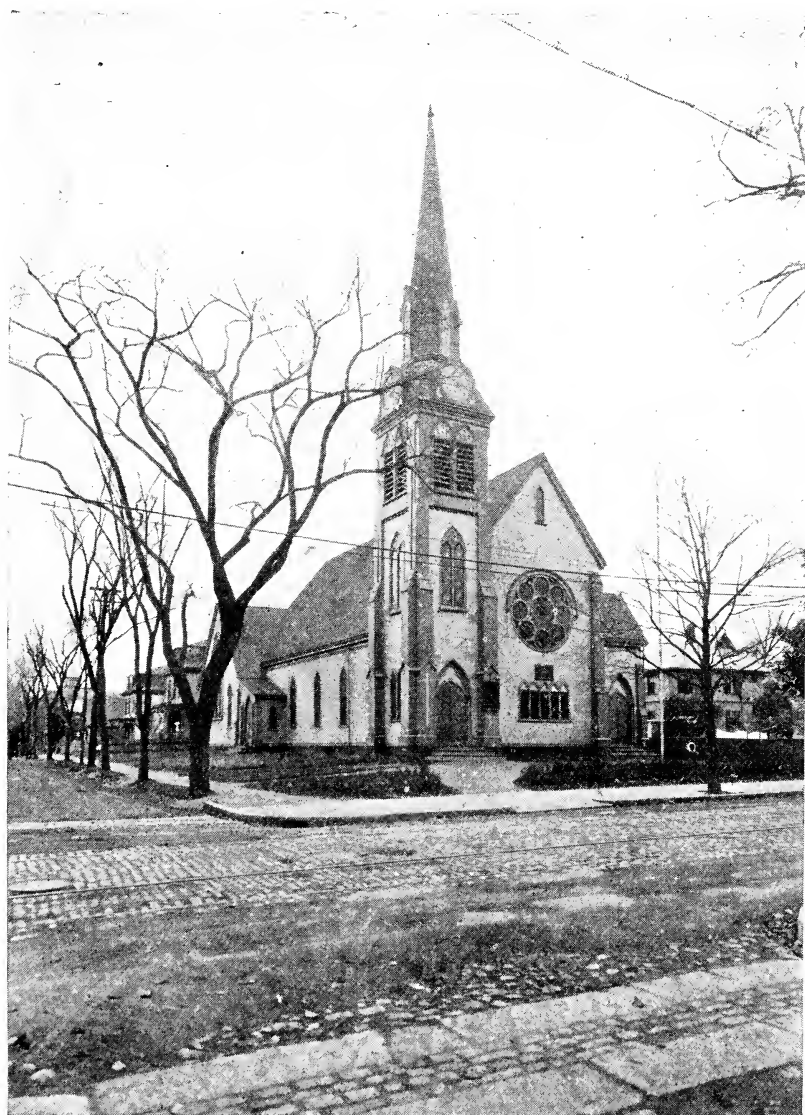
ILLUSTRATION 12. MAPLEWOOD BAPTIST CHURCH

The total score allotted this church is practically the same as that for the Eastern Avenue Baptist, although the exterior views would not show them equal. The Maplewood Baptist is a distinctly church-like frame structure but there is little to commend in its internal structure. The building has not been recently redecorated, and little attention has been paid to general esthetic effect. The building is a fire-trap from the rubbish-strewn, ash-filled basement to the paper-filled closet under the roof. The service systems are old, insufficient and poorly installed, particularly the heating, lighting, and toilet systems. The religious school rooms are too few, poorly arranged, and equipped with old and uncomfortable furniture.

The church is used for some community activities now, though its equipment for this form of service is very inadequate and in a discouragingly poor condition. A church library is provided though it has the appearance of being seldom used. It would be possible greatly to increase the community service of this present plant, although no amount of remodelling would make it approach the standards for the various items.

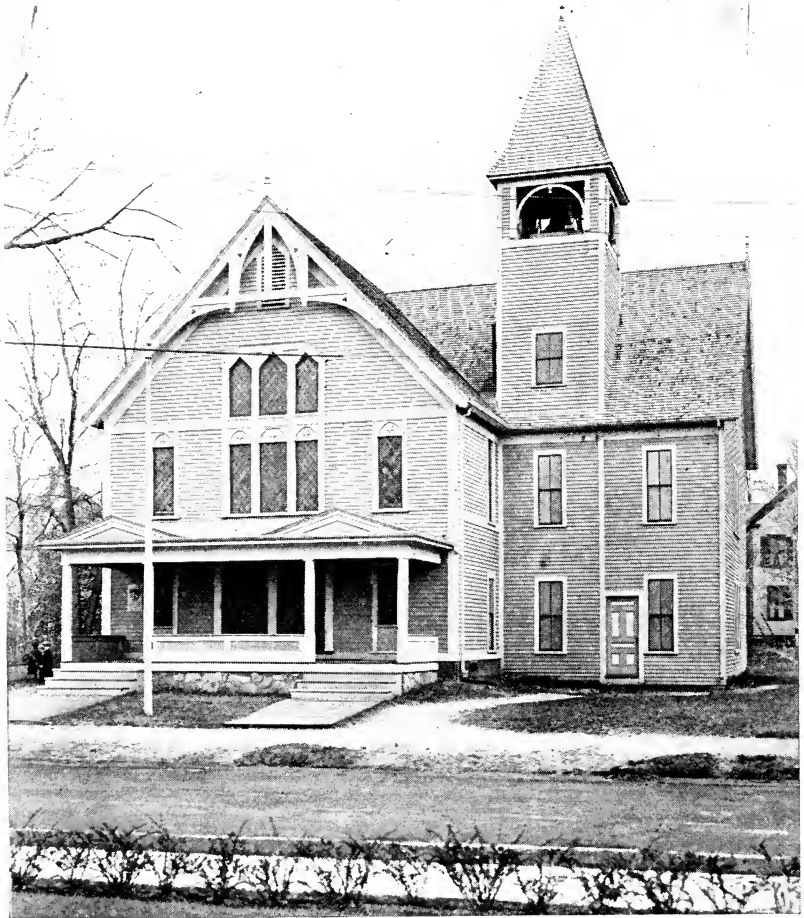
ILLUSTRATION 13. LINDEN CONGREGATIONAL CHURCH

The Linden Congregational Church was allotted about one-third of its possible score. This is due in part to the fact that it is a small church serving a small congregation and seriously limited not only in its equipment but also in the lines of activity it can support. It is possible that much more would be gained if congregations of this size would give up a little of the convenience of easy accessibility and attend a larger community center church which possesses the physical equipment necessary for a richer program of religious instruction, and community service.

The site of this church is too small for anything but the building to stand upon and is also poorly drained. The present building serves as a handicap, not only because of the meager number of rooms available but also because of their poor equipment. The main auditorium being on the second floor with inadequate means of access is a source of both inconvenience and danger, even though it makes possible a first or ground floor without any excavation for a basement.

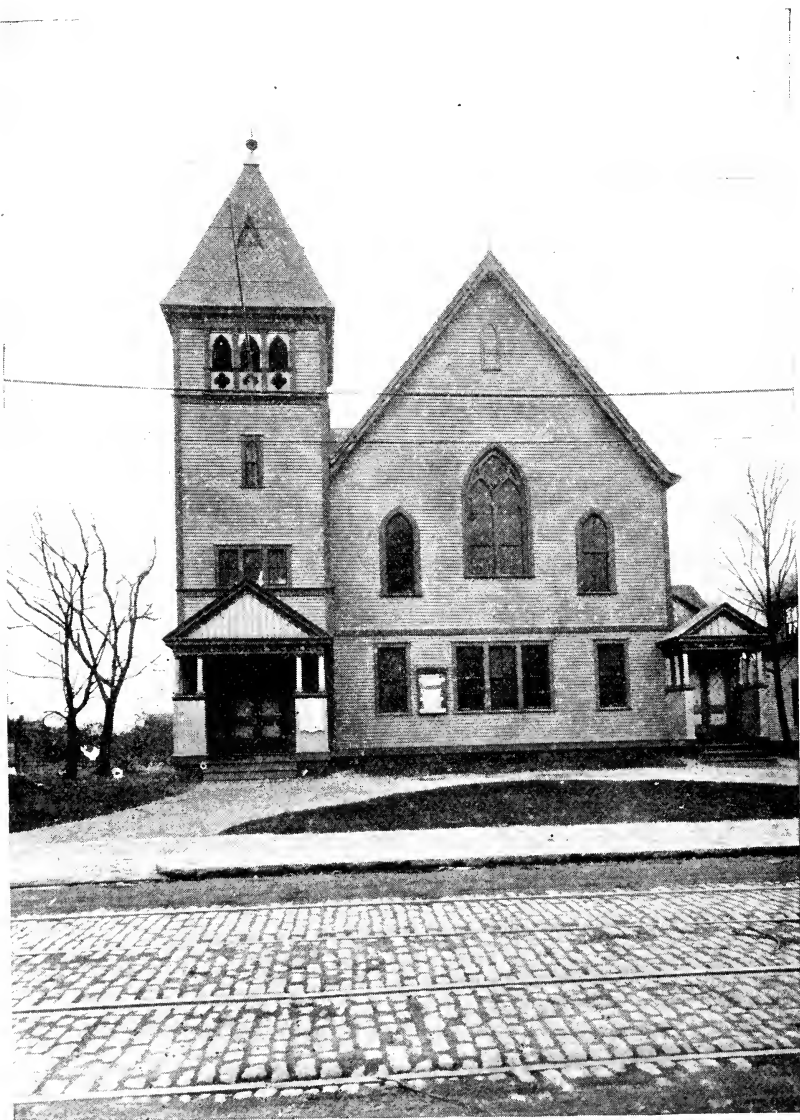
ILLUSTRATION 14. MAPLEWOOD METHODIST CHURCH

This is another church which reaches about one-third of its possible efficiency as shown by its total score. For reasons previously given, probably it would better be abandoned in order that its congregation might join forces with some larger, better equipped church.

The building is old and poorly arranged. The rooms used for religious instruction are well grouped although they are inconvenient of access and poorly furnished. The service systems—heating, lighting, toilet, water supply and fire protection are among the poorest in all of the churches in the city. As in many of the smaller churches, the auditorium is the most commendable room of the church, but this one is made less so by being on the second floor and provided with very inadequate stairways. Almost no effort has been made to do any form of community service other than the traditional, distinctly religious forms. The present church plant would seriously lessen the chances of success for any such program.

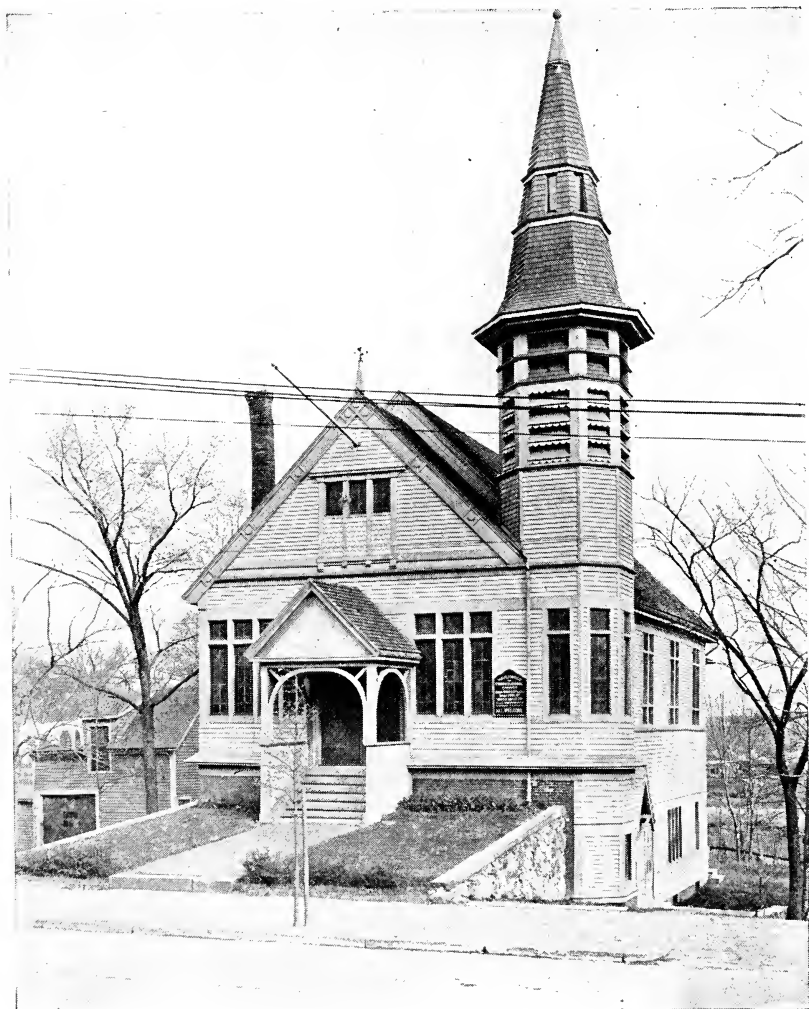
ILLUSTRATION 15. MAPLEWOOD CONGREGATIONAL CHURCH

This frame church is built on a site inadequate for any other purpose than the location of a building. The site is on such a steep slope that it prevents the use of any part of it or of nearby ground if acquired for any service. Landscape effects are almost impossible and the low, swampy land at the rear of the site prevents any expansion in that direction. The main elements in this situation are a church auditorium, rather severe but well maintained and a school assembly room about which there is little semblance of modernity. With limited equipment, a paucity of classrooms and almost no suitable service rooms, this plant can render only in slight degree the community service which might be possible.

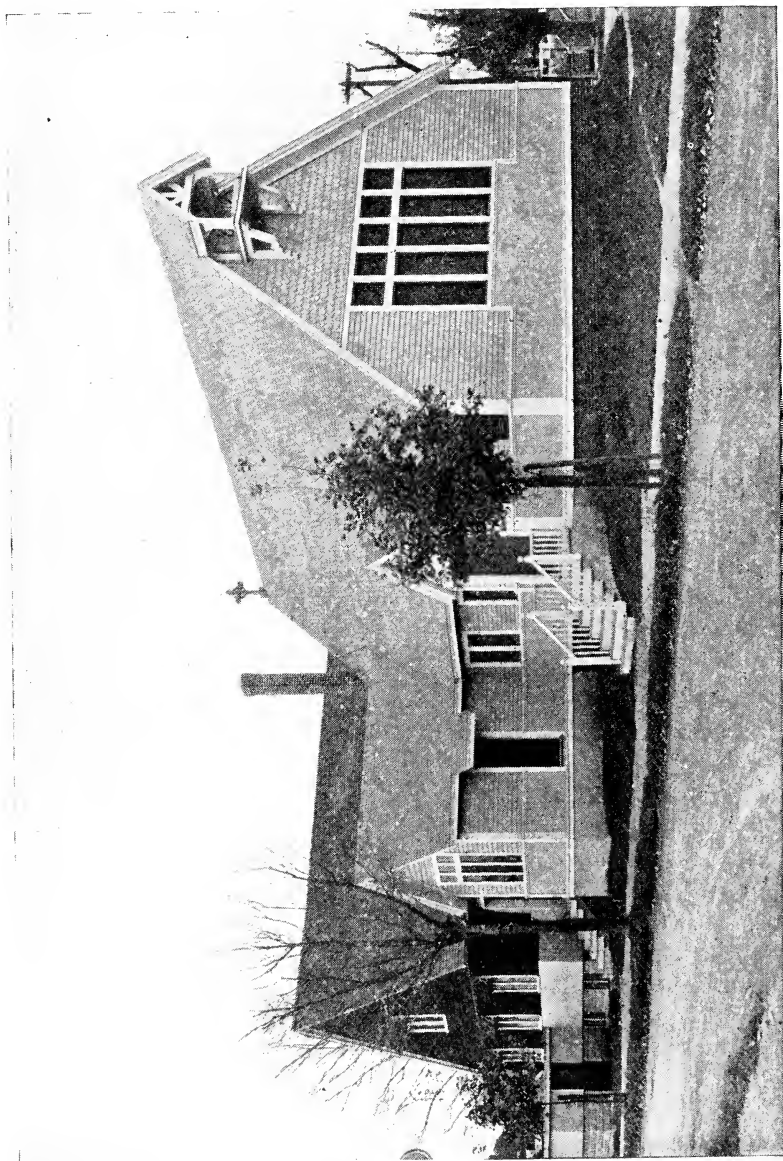
ILLUSTRATION 16. ST. LUKE'S EPISCOPAL CHURCH

Although this church is located in one of the less densely settled sections of Malden, its buildings cover a very large part of its site. The Linden section of Malden cannot adequately support three or four large community service church and religious education plants. The inadequate plants which exist there today are evidence of this fact. A cooperative community spirit should produce one large community house for this section. Such a plan need not interfere with differences in forms of worship but could assure religious education for the children and service for adults far beyond what has been found possible in the existing churches.

About half of the score on this building has been allotted to the site. There is little else about this plant that has anything to commend it. It represents very little achievement on the part of any community group and should be replaced at the earliest moment by a standard plant.

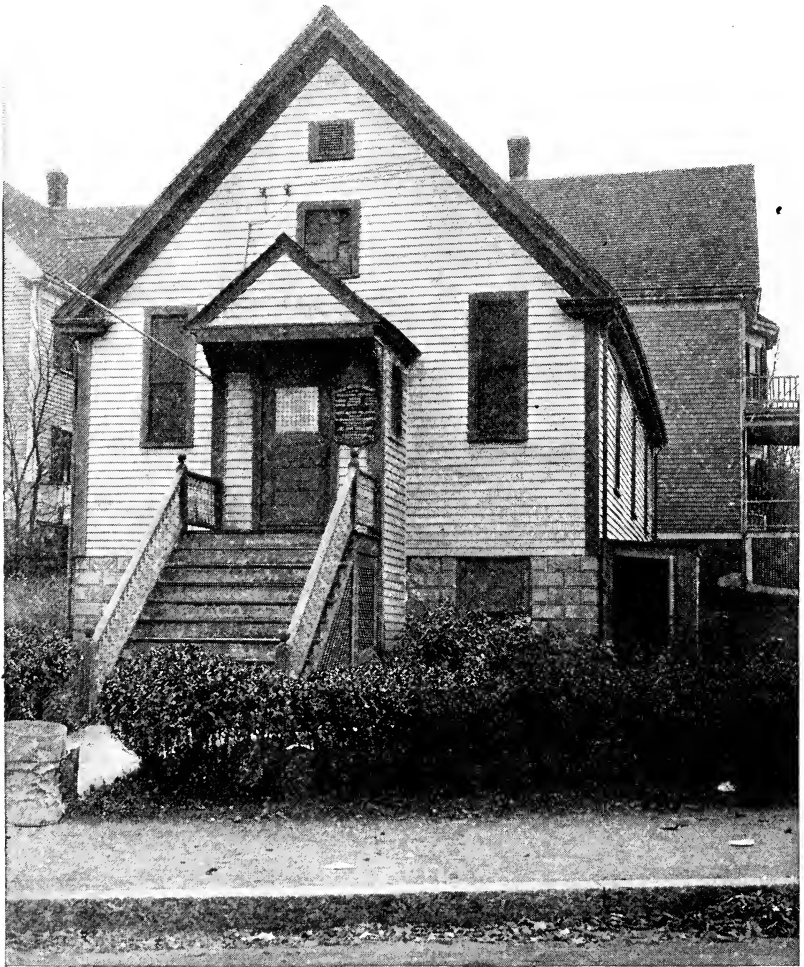
ILLUSTRATION 17. UNION BAPTIST CHURCH

Score Card Item	Allotted Score	Maximum Possible Score
I. Site.....	98	130
II. Building.....	44	150
III. Service Systems.....	26	160
IV. Church Rooms.....	37	170
V. Religious School Rooms.....	13	200
VI. Community Service Rooms....	7	190
Total.....	225	1,000

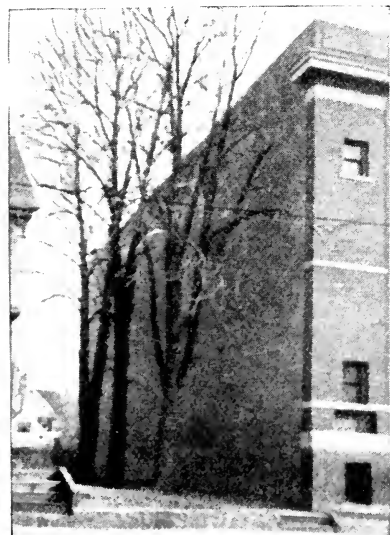
ILLUSTRATION 20. BLANK WALL OF PARISH HOUSE, FIRST BAPTIST CHURCH. THIS PREVENTS ADEQUATE LIGHTING OF LARGE ROOMS

Perhaps the most outstanding result of the effect of an inadequate site in a particular situation is that evident from study of illustration 22 and 20, pages 59 and 57. The religious school building of the First Baptist plant presents an attractive appearance from the church side. The site, however, is so small that it was considered necessary to build this structure with one side close to the neighboring property line. The building, on this side, has been given a blank wall, thereby detracting to a considerable degree from its beauty both within and without and from the advantages that accrue from good natural lighting of classrooms. A school building of this size requires a site sufficiently large for play and pageantry purposes.

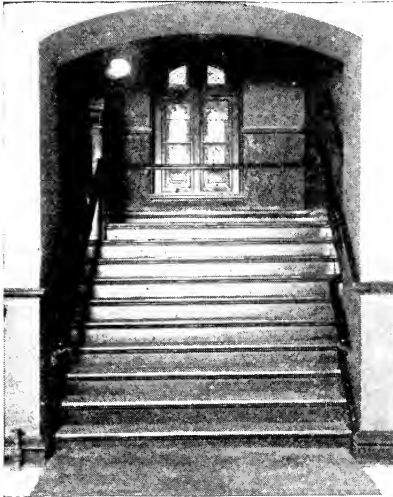
ILLUSTRATION 25. ONE OF TWO MAIN STAIRWAYS FROM THE LARGE AUDITORIUM OF THE CENTRE METHODIST CHURCH

Illustrations 25 and 26, page 65 show two of the three main stairway exits for the large Centre Methodist auditorium. The front stairways are not provided with adequate natural light. These stairways are not well conceived for the passage of large groups from the auditorium and balcony floors. The rear stairway requires an additional turn at the bottom before the exit doors can be reached. This makes a total of four turns which must be made by a group descending from the second floor to the side entrance. The standard that no storerooms be placed under the stairways unless fireproof is violated in the case of these two stairways.

could reach safety. It is unfortunate that this auditorium has been located as it is. The close proximity of other non-fireproof buildings, the non-fireproof nature of the Centre Methodist structure and the wooden construction of its stairways, as shown in illustrations 25 and 26, page 65, make further precautions for safety quite necessary. Other elements adding to the dangers are the store rooms, and other rooms under the stairways and the fact that the balcony with its seating capacity of 350 to 400 may be considered as being on the third floor.

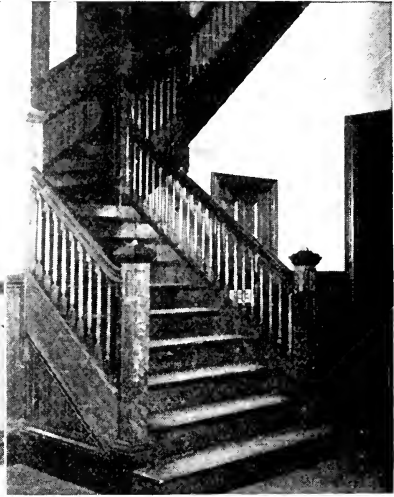
ILLUSTRATION 26. A WOODEN STAIRWAY OF QUESTIONABLE VALUE IN TIME OF DANGER. CENTRE METHODIST CHURCH

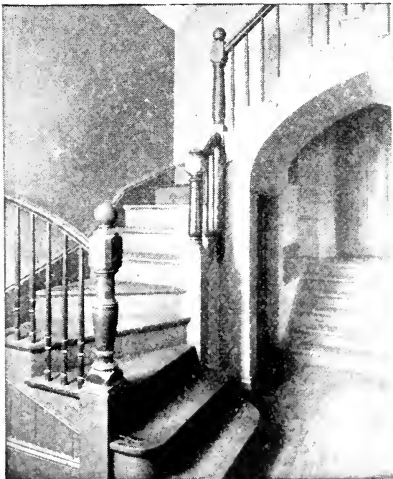
ILLUSTRATION 27. DANGEROUS WINDING STAIRS FOR PRIMARY CHILDREN. ST. PAUL'S EPISCOPAL CHURCH

Illustrations 27 and 28, page 65, of stairways, Maplewood Baptist and St. Paul's plants respectively, are other types of stairways to be found in the seventeen plants. The first stairway is narrow, without handrails and artificial light, doubles back on itself and is located directly over a stairway leading to the littered cellar of illustration 43, page 80. The second stairway is a winder of a very bad type, and lacks handrails and sufficient artificial light. It leads to a classroom where

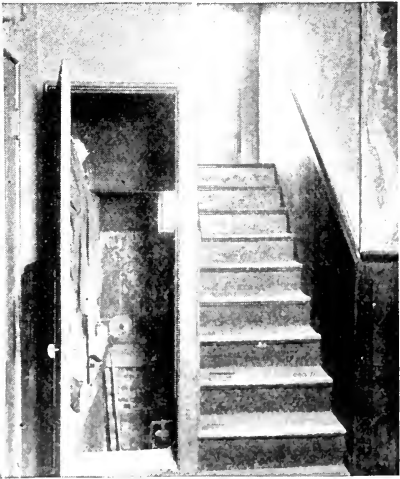
ILLUSTRATION 28. A PROBABLE DEATH TRAP IN CASE OF FIRE. MAPLEWOOD BAPTIST CHURCH

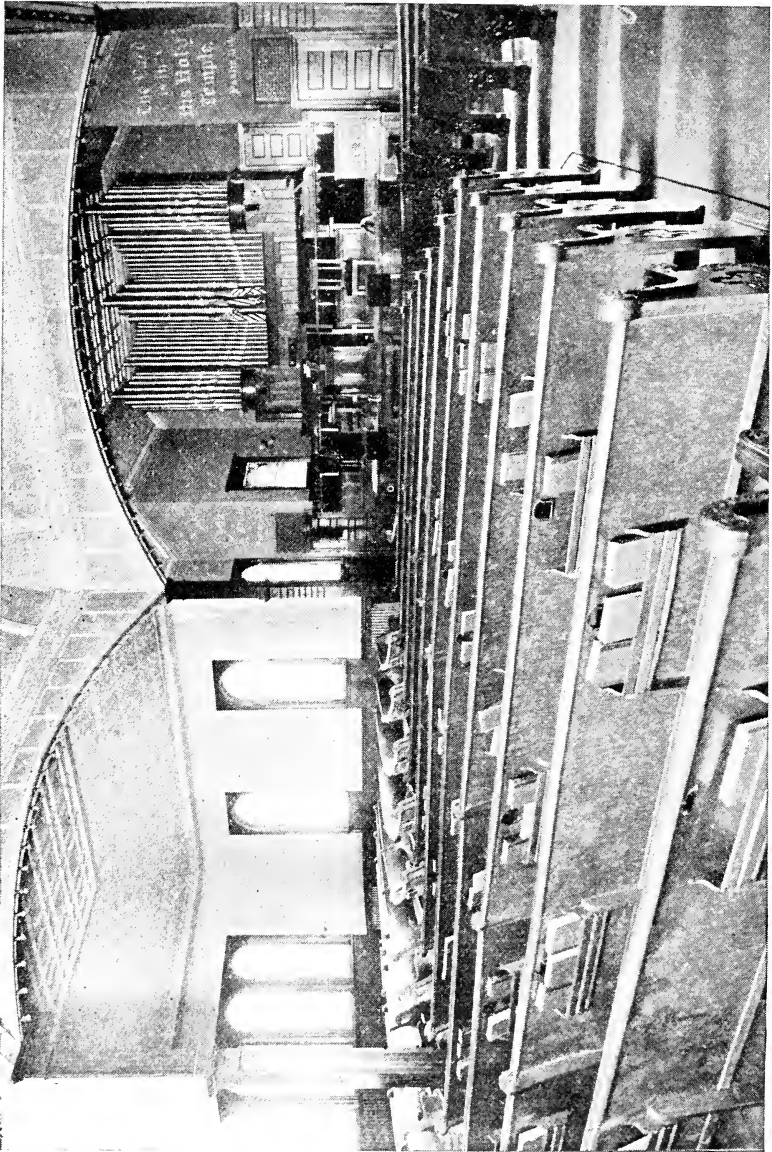
ILLUSTRATION 29 THE SECOND STORY AUDITORIUM, ROBINSON METHODIST CHURCH, THE ONLY EXIT FROM WHICH APPEARS IN ILLUSTRATION 31

The "second story" auditorium of the Robinson Methodist presents nearly equal possibilities for disaster. The exterior view of the Robinson Methodist in illustration 5, shows the steep ascent from the ground level to the first floor. A second steep broad stairway without adequate handrails runs from the first floor as shown in illustration 31, page 67, to the floor of the auditorium shown in illustration 29, page 66. The extreme width of this church auditorium would add to the danger in case of fire. The careless storage of old shingles and other materials in such a manner as to increase the fire danger was noticed in this basement.

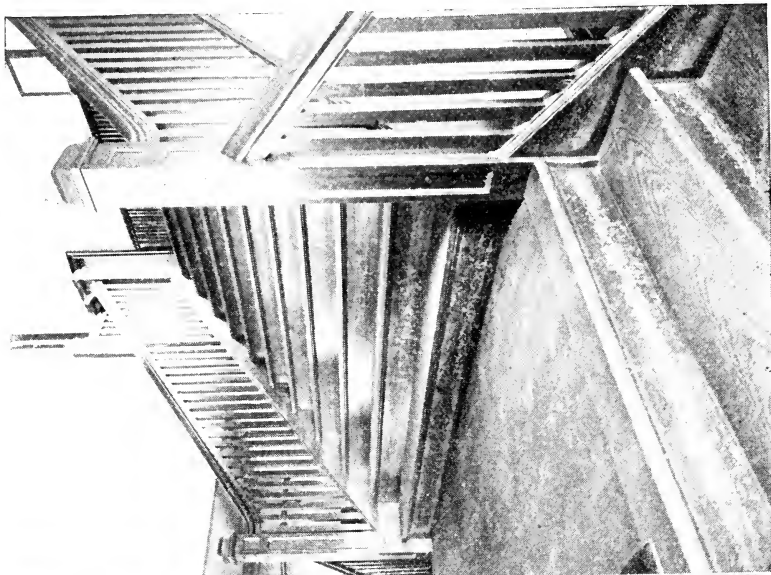
ILLUSTRATION 31. BY ADDING THIS STAIRWAY TO THAT OF ILLUSTRATION 30 ONE MAY VISUALIZE THE ONLY APPROACH TO THE ROBINSON METHODIST AUDITORIUM
